FABRIC DEFECTS

CASE HISTORIES OF IMPERFECTIONS
IN WOVEN COTTON AND RAYON FABRICS

J. B. GOLDBERG

Fellow of the Textile Institute
Research Director, J. P. Stevens & Co., Inc.

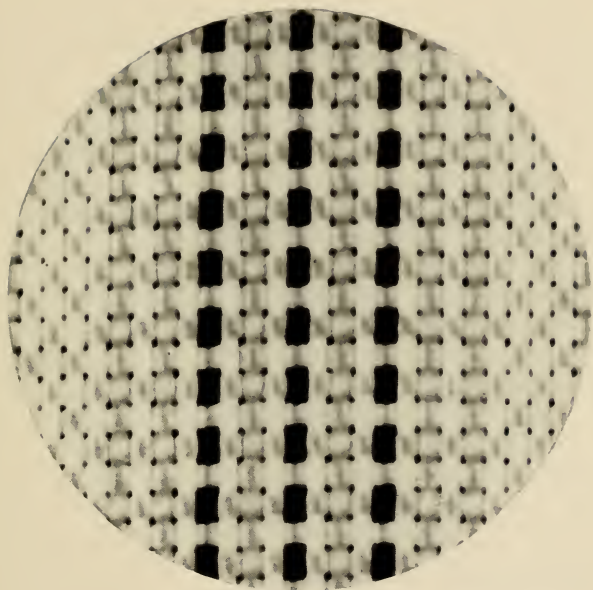
Actual measurements showed a decided difference between the crimp of the warp yarns in the dark-banded sections as compared with those in the light sections. For example, where there appeared to be a dark band, the contraction of the black-dyed yarn was found to be approximately eight times as great as it was in the light sections. This additional black-dyed yarn covered more of the adjacent lighter dyed yarns and produced the illusion of filling bands. This fabric was woven with multiple warp beams, and the defect was apparently caused by a periodic variation in the loom let-off of one beam during weaving, resulting in more contraction in the black-dyed yarn.

FIG. 29a. Normal warp contraction in black yarns.

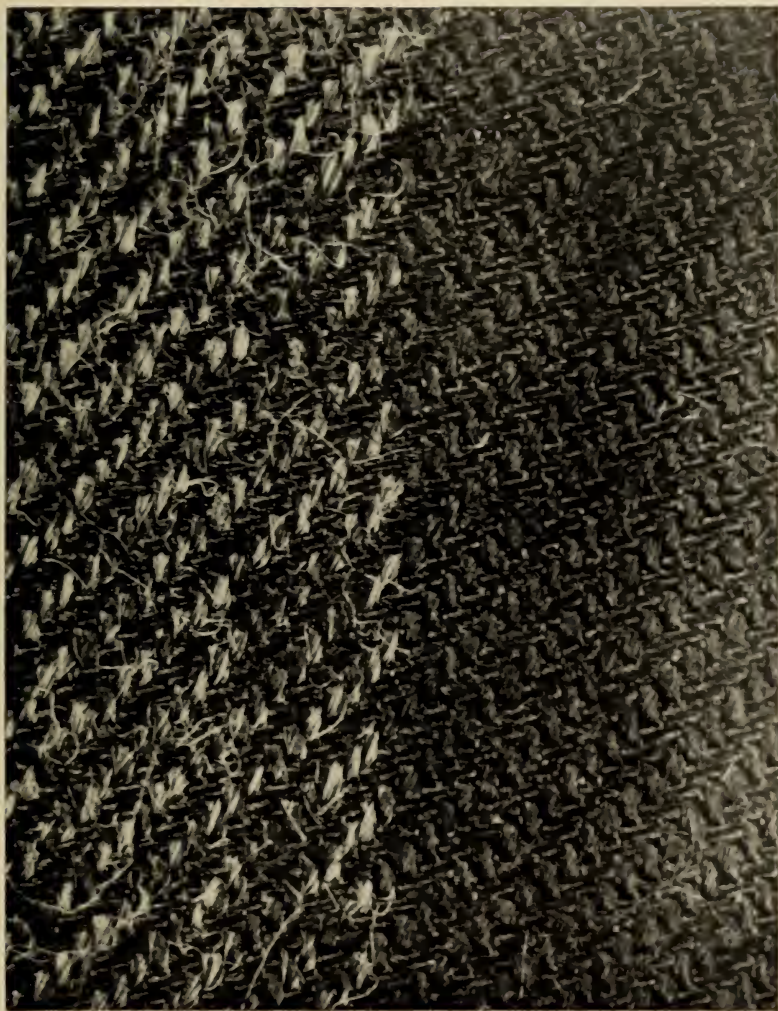
The light filling bands in the sample submitted were found to contain yarn composed of one roving of spun viscose and acetate and one roving of all-bright spun rayon and wool. Since the wool remained undyed, the resultant bands of this yarn were lighter in shade than the normal blend. This defect was produced by the mixing of rovings in the mill during spinning.

FIG. 31. Band due to mixed roving containing undyed wool.

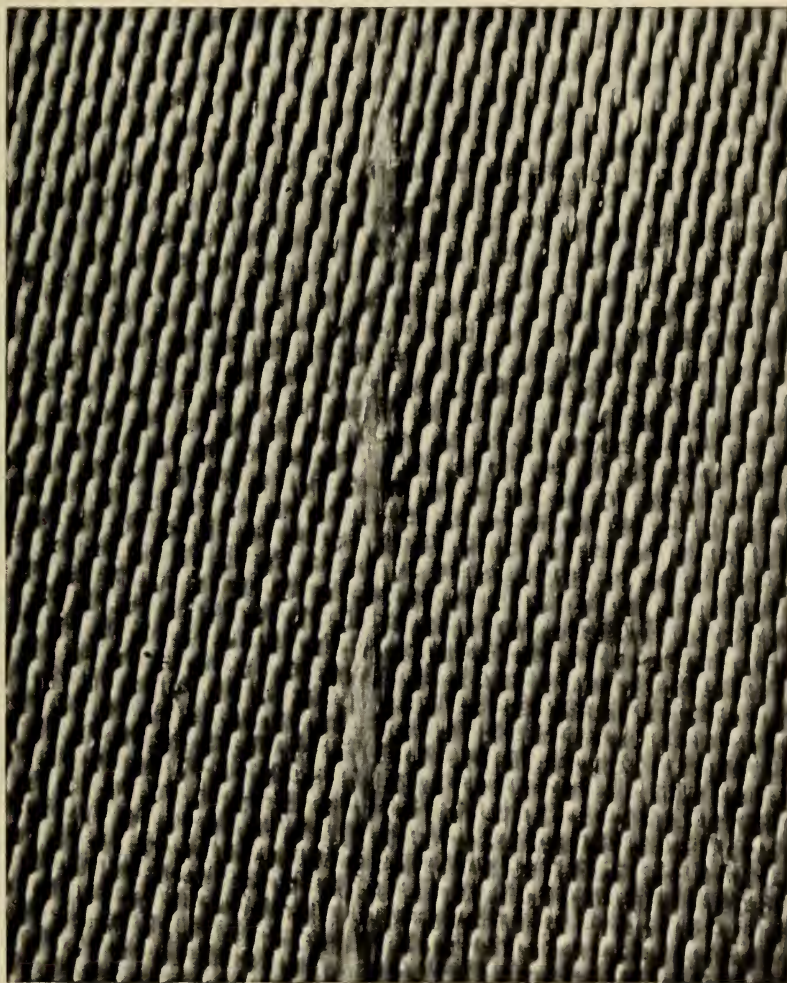
The "dotted-line" effect in the warp was found to be due to a harness skip, resulting in one of the acetate warp ends' floating over several picks at intervals, thus becoming more pronounced on the surface.

FIG. 32. Floating end due to harness skip.

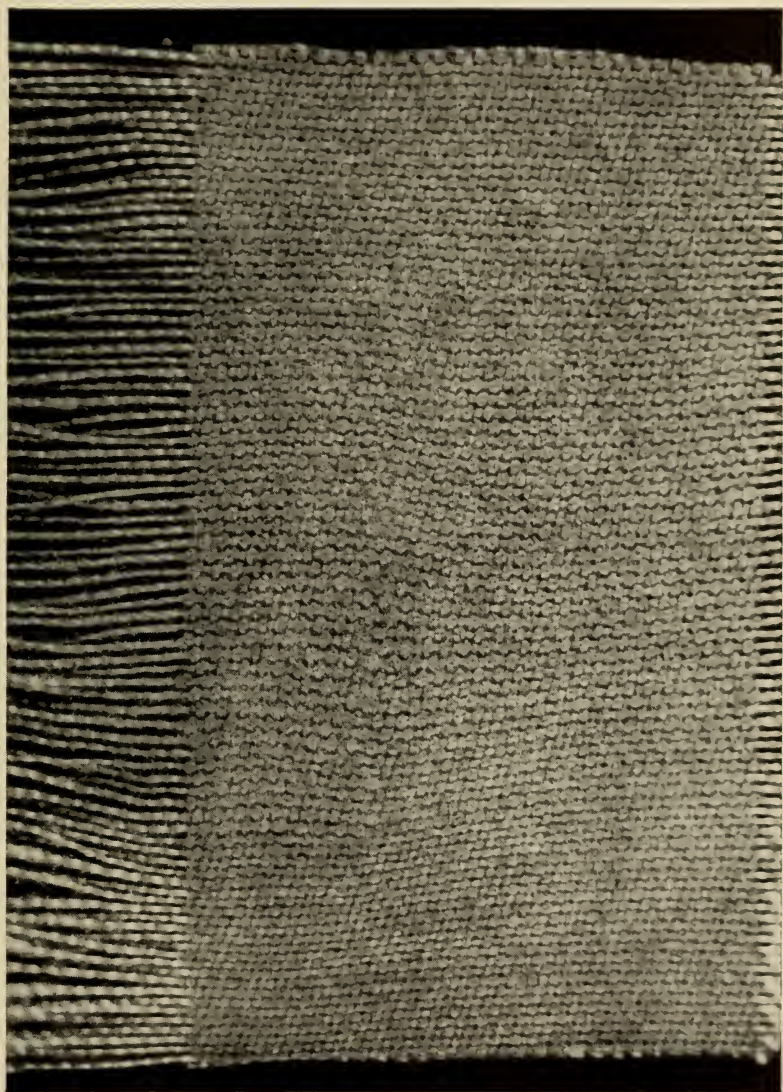
Examination showed that this blotchy effect was due to uneven pickage and distortion of the filling threads in numerous small areas. This condition was attributed to so-called "finger marks" caused by pressure of a worker's hands on the warp in the loom during weaving, with subsequent distortion resulting in uneven laying-in of the picks in the woven goods.

FIG. 39. Filling distorted by finger marks.

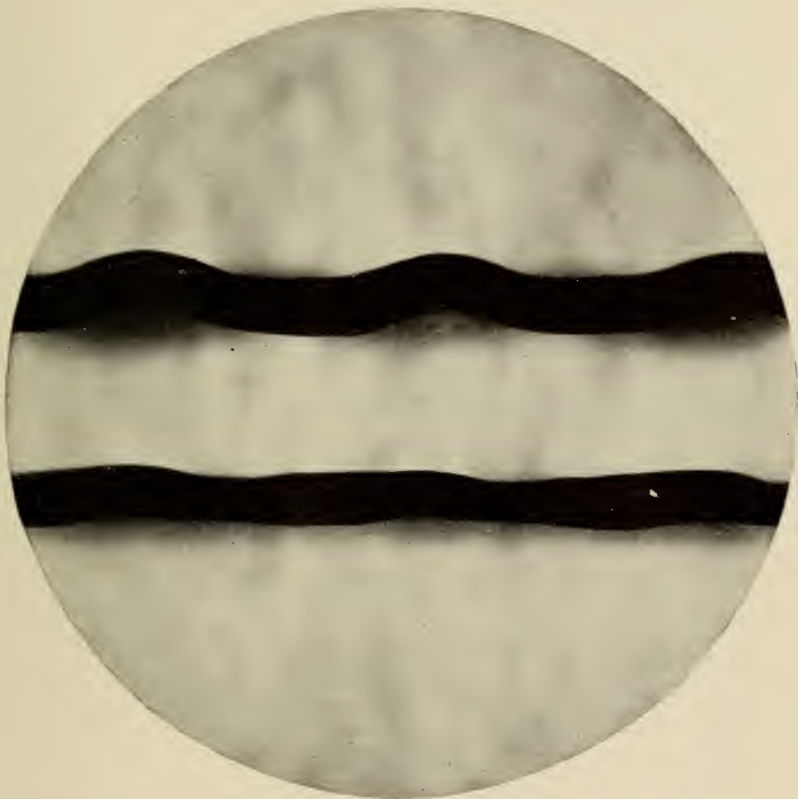
Denier, filament count, twist, and rayon identification of the bright-appearing ends showed no abnormal condition. Single-strand elongation tests, however, showed the two ends in question to have abnormally low breaking strength and elongation and, in removing them from the fabric, it was found that they had much less crimp than adjacent normal warp ends. This defect was due to stretched warp ends probably caused by excessive tension during weaving. Theoretically, the denier of these ends should be slightly lower than normal, owing to the overstretching, but it has been found that changes in the stress-strain characteristics of the yarn are a much more reliable measure of overtensioning.

FIG. 40. Variation in yarn crimp.

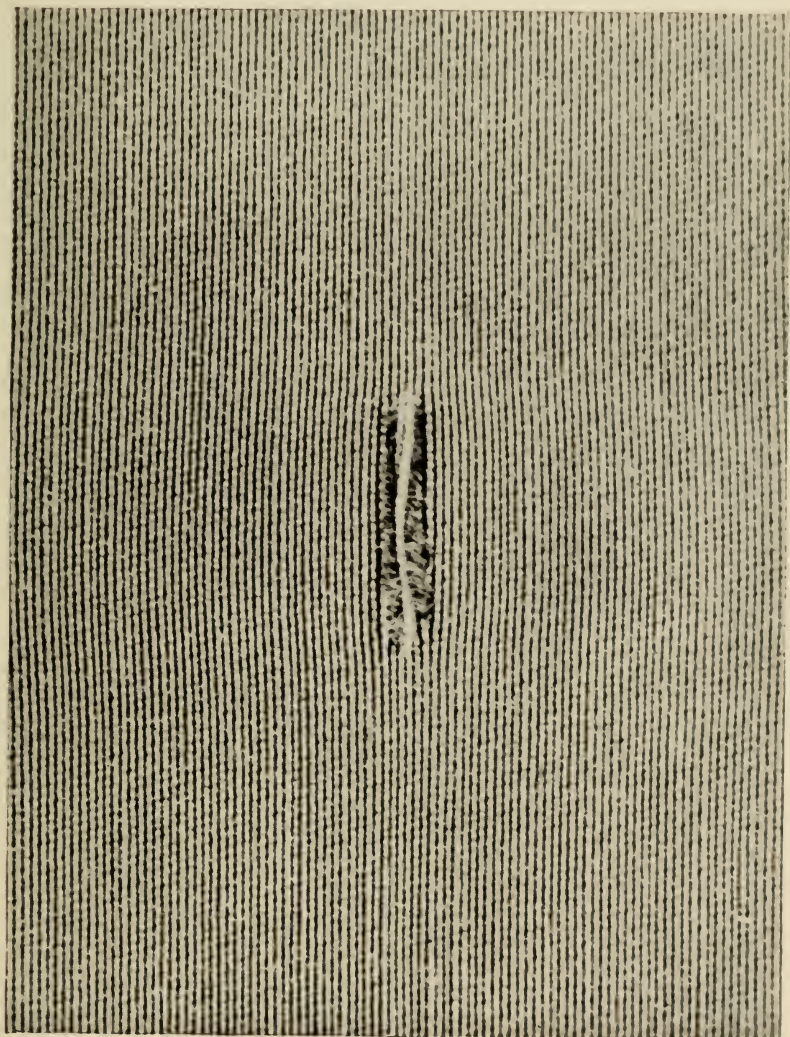
This defect was attributed to the presence of oily filling yarn containing small amounts of iron from contact with machine bearings. When the cloth was subjected to bleach, the iron acted as a catalyst, accelerating the oxidation and producing oxycellulose in the cotton filling yarn and in the rayon warp yarn through direct contact. The rayon yarns being much weaker when wet, and excessively tender in those sections, broke when the goods were finally finished.

FIG. 41. Tendering in bleaching due to presence of iron.

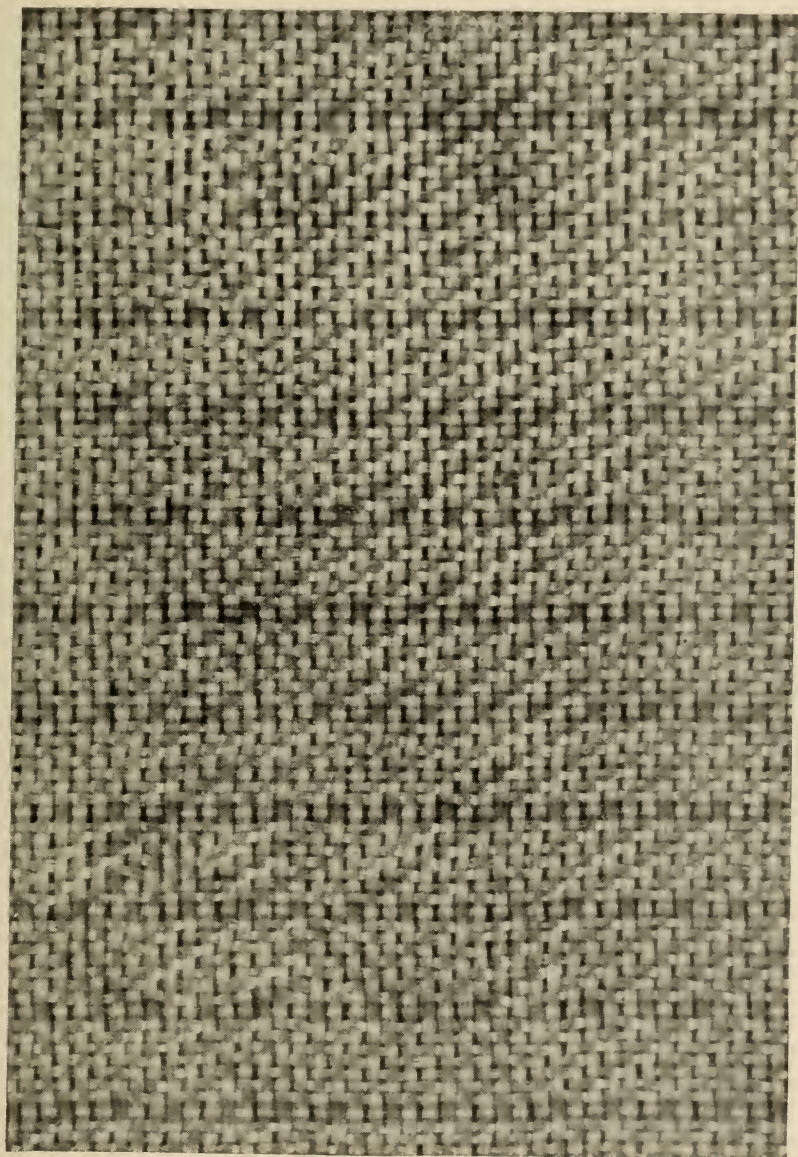
It was found that the streaks appeared as bright ends at intervals in a regular pattern, repeating on every eighth end. Investigation showed that this construction had been slashed from eight section beams. Physical tests on the bright-appearing warp ends indicated that they were under greater tension than the remainder of the warp and this resulted in greater light reflection. The defect was attributed to excessive tension applied to one section beam during warping.

FIG. 42. Streaks due to tight section beam.

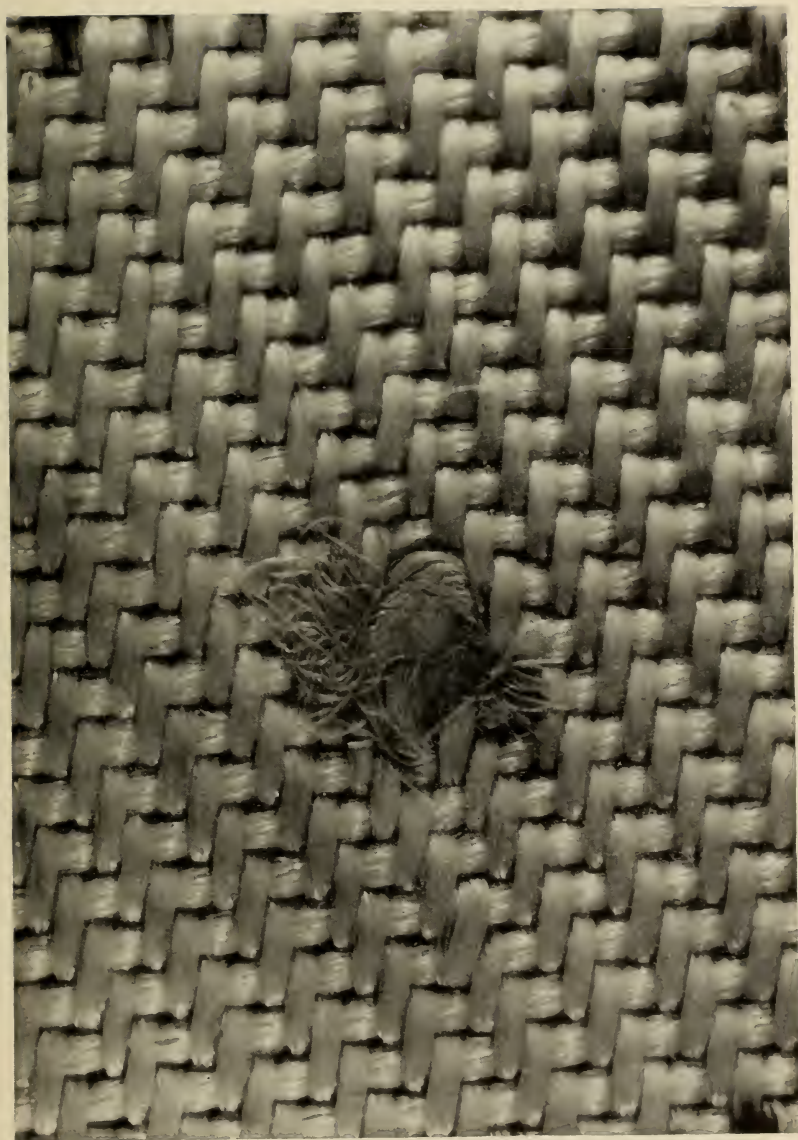
FIG. 43. "Spot" due to dirty knot.

In certain cases in which the classification of such goods as suitable for white and light shades may command a premium price, it is sometimes possible for the finisher to use special scouring procedures which will result in removal of most of the soil in such dirty knots, but this special handling is necessarily more costly and necessitates extra charge by the finisher.

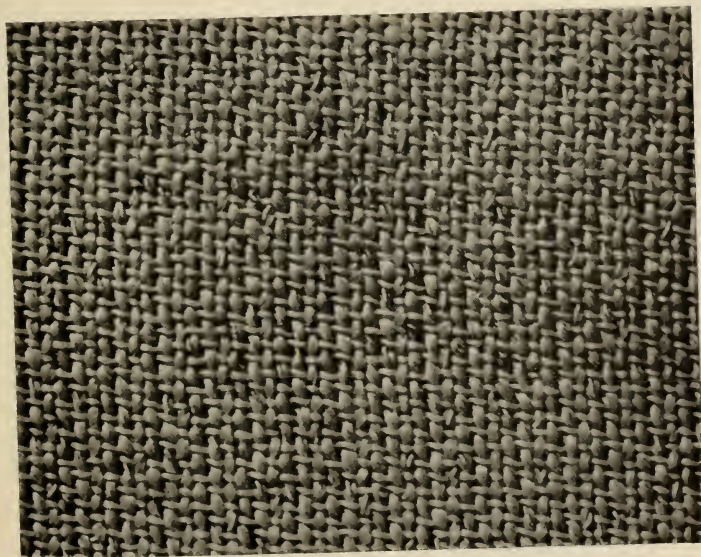
FIG. 44*b*. Defective—absence of ribbed effect.

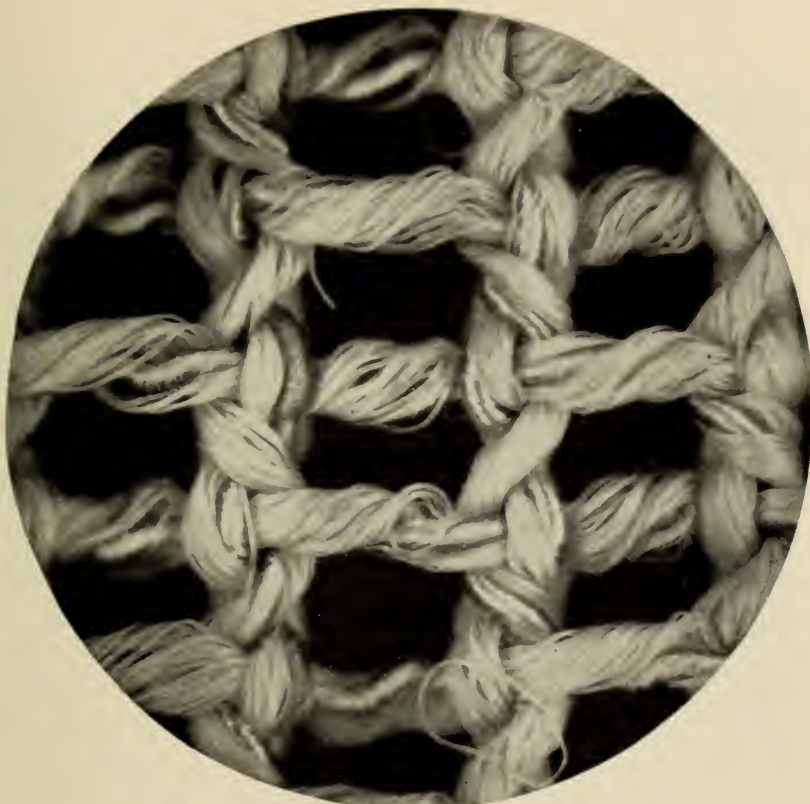
Analysis of the sample submitted showed that the single streak was due to the presence of a Z twist rayon-crepe end in one of the combination yarns, instead of all-S twist as specified. Furthermore, it was observed that the particular Z-twist yarn in question had a residue of a dark-colored tint, which made it even more prominent in the dyed fabric. However, the incomplete removal of the tint was considered to be of secondary importance, since the difference in twist alone would result in the appearance of a streak.

FIG. 46a. Streak due to single Z twist crepe yarn.

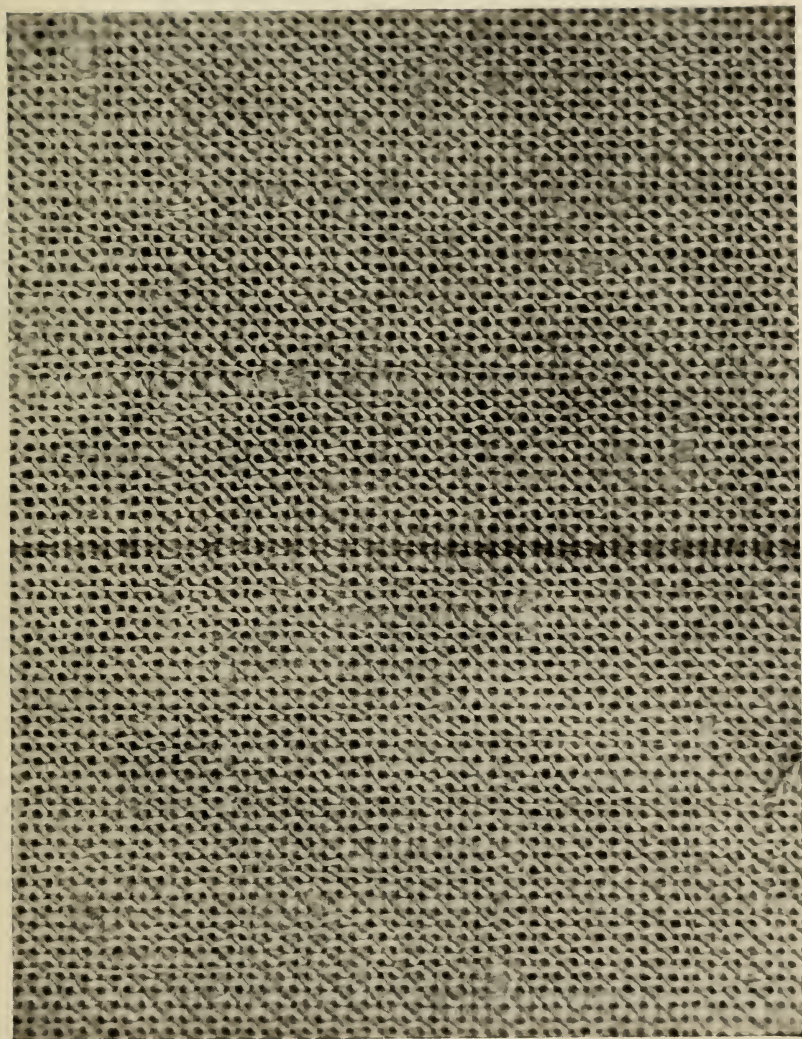
It was found that the single darker dyeing end was of a different size (32/1 instead of 14/1) and was composed of a blend of 50% 1½-inch 1½-denier bright viscose and 50% 2-inch 3-denier dull acetate, instead of as specified. Furthermore, chemical tests showed that the acetate fibers had been saponified, probably because of a causticizing treatment of the goods by the finisher, which might be considered a normal operation for what was supposed to have been an all-viscose fabric. As a result of this saponification, the foreign end became more noticeable than the off-size alone would indicate, owing to the fact that the converted acetate dyed darker than the normal all-viscose yarns.

FIG. 47. Foreign end containing acetate saponified prior to dyeing.

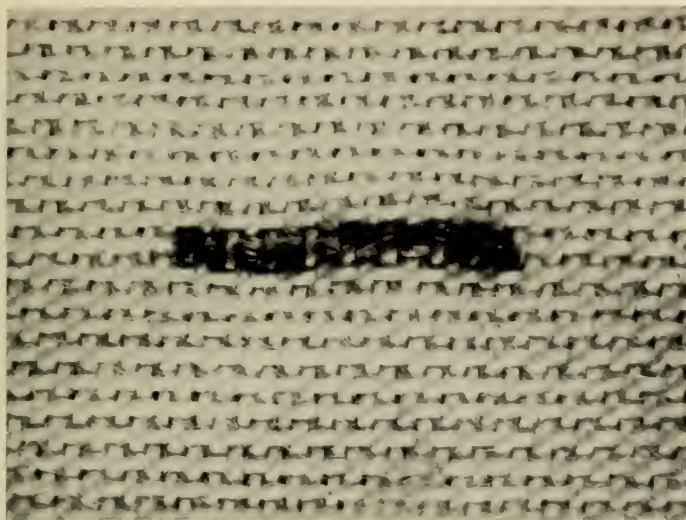
Inspection of a number of pieces showed no regular pattern to the defect, the stains being, in general, fairly small and scattered. Chemical tests revealed the presence of iron. By a study of a great many of the discolored areas under the microscope it was discovered that there were small bits of fine wire spun into the yarn in four or five different places. Further investigation revealed that these wire particles came from the steel wool used in floor-cleaning machines recently put into use in the mill and had been accidentally discharged through a hole in the dust-collecting bag, so contaminating some of the rayon stock prior to its being spun. The metal particles rusted when the goods were processed at the finishing plant and batched up while wet, and most of the stains were due to mark-offs from the original heavily rusted areas. The finisher was able to correct this defect by treatment of the goods with oxalic acid, to remove the stains before dyeing.

FIG. 48a. Stain in dyed fabric.

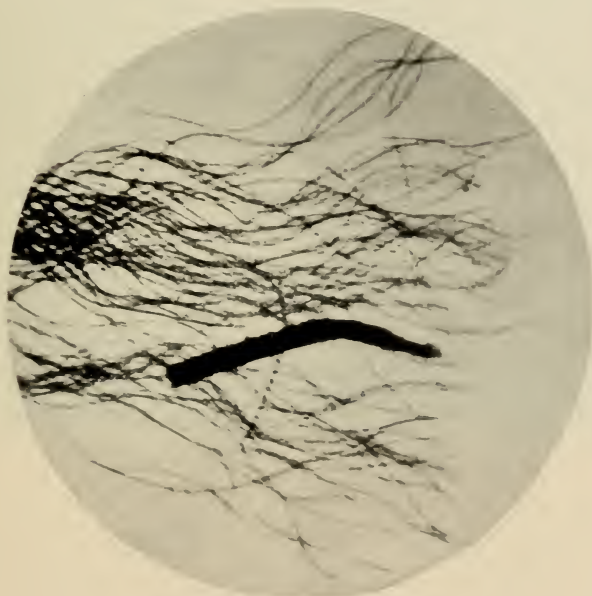
FIG. 48b. Wire in spun yarn.

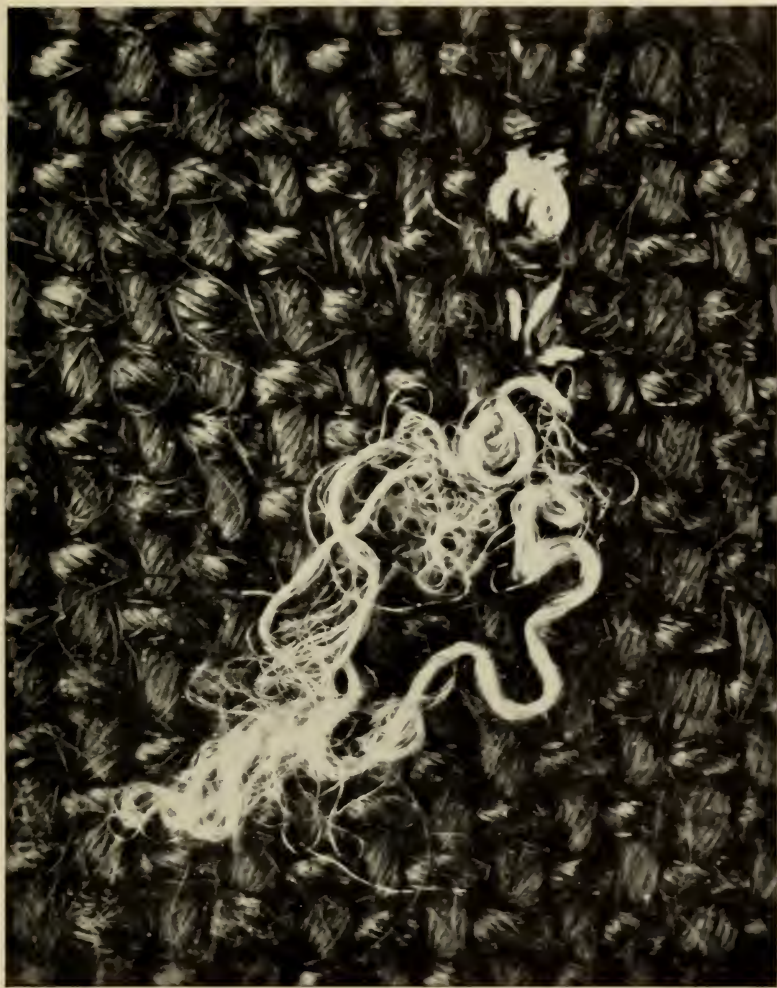
FIG 49. Specks due to undyed silk thread.

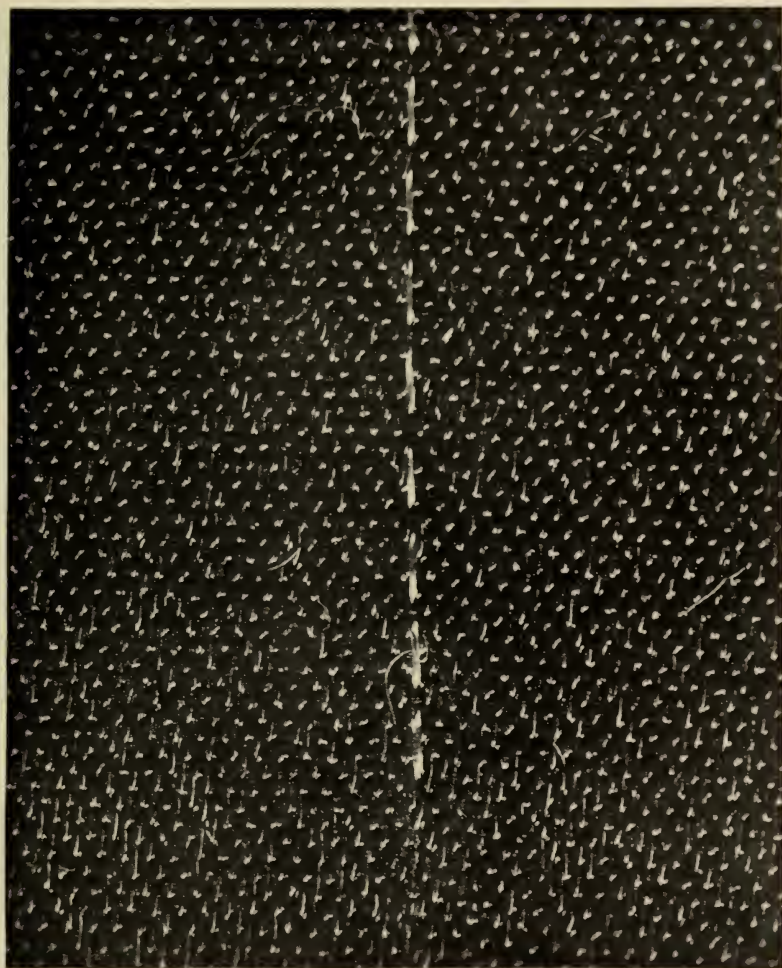
FIG. 51. Mixed piecing during weaving.

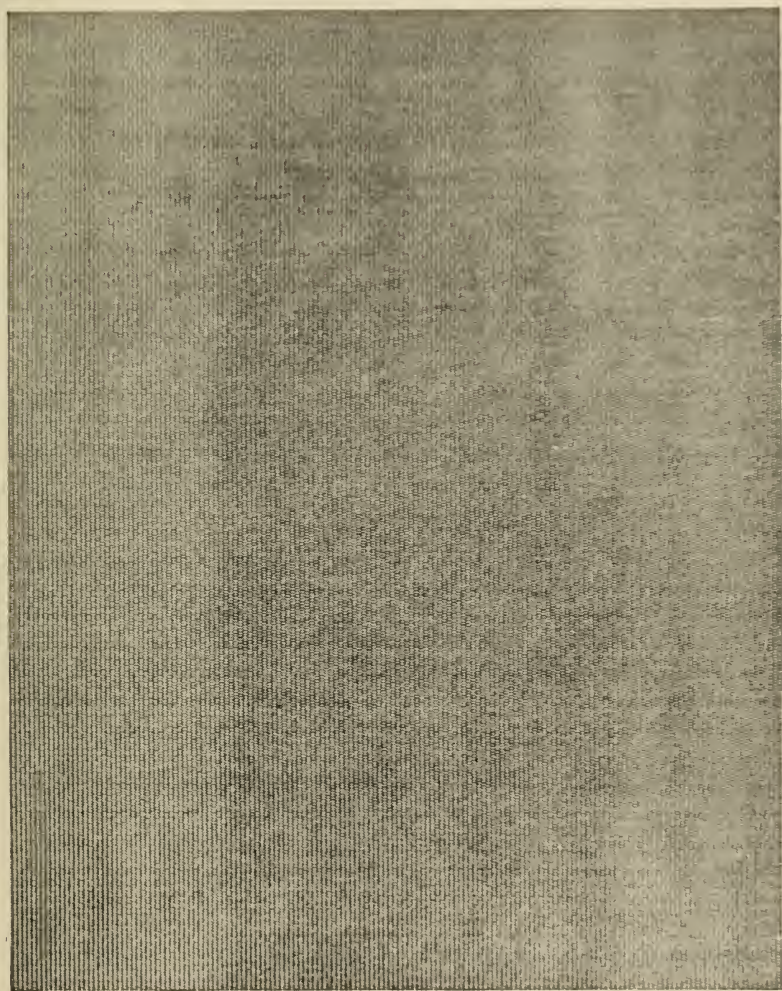
FIG. 52. Yarn stained by bobbins varnish.

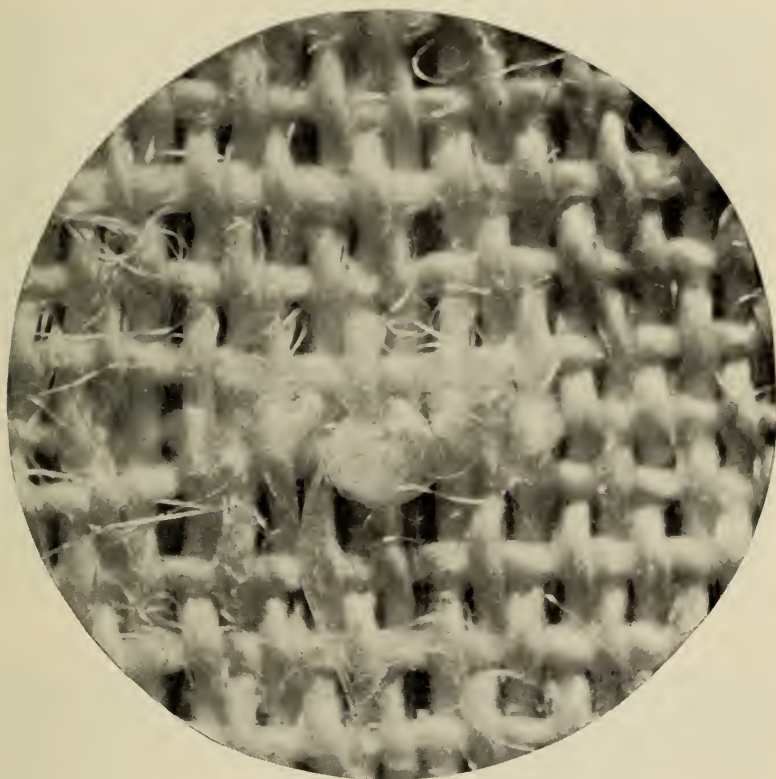
FIG. 53a. Hole due to filling break.

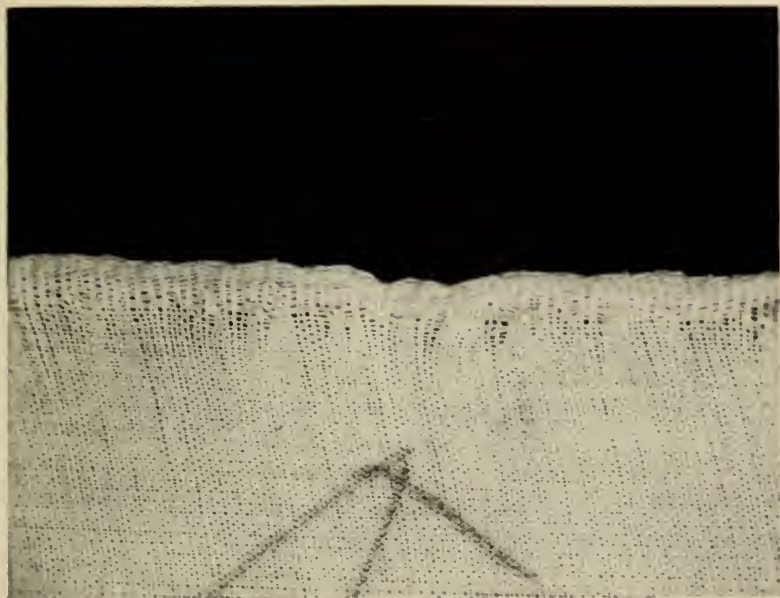
FIG. 54a. Poorly woven selvage.

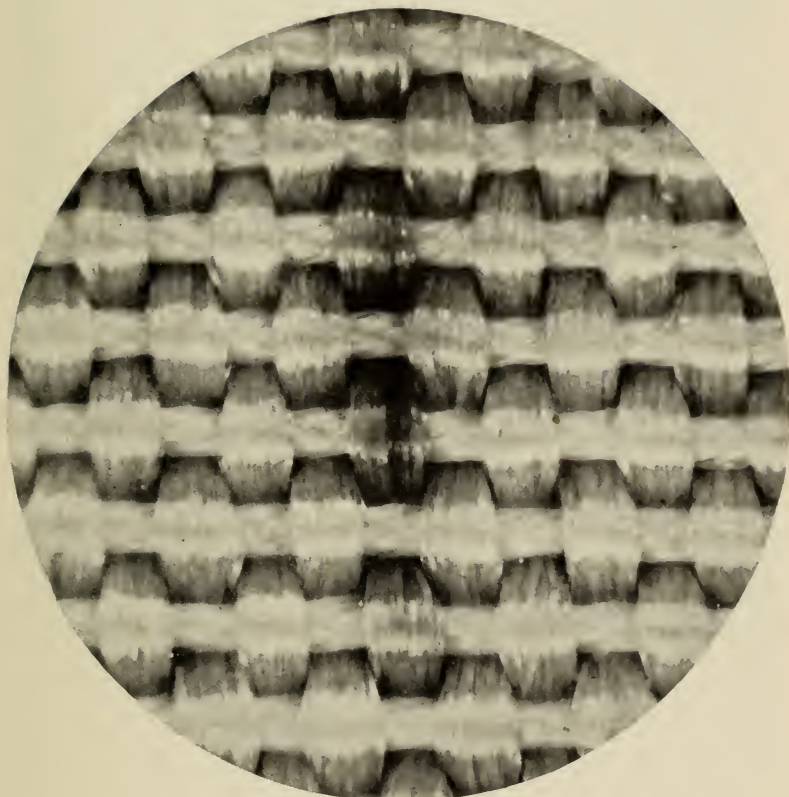
FIG. 55. Nonfugitive tint on warp yarn.

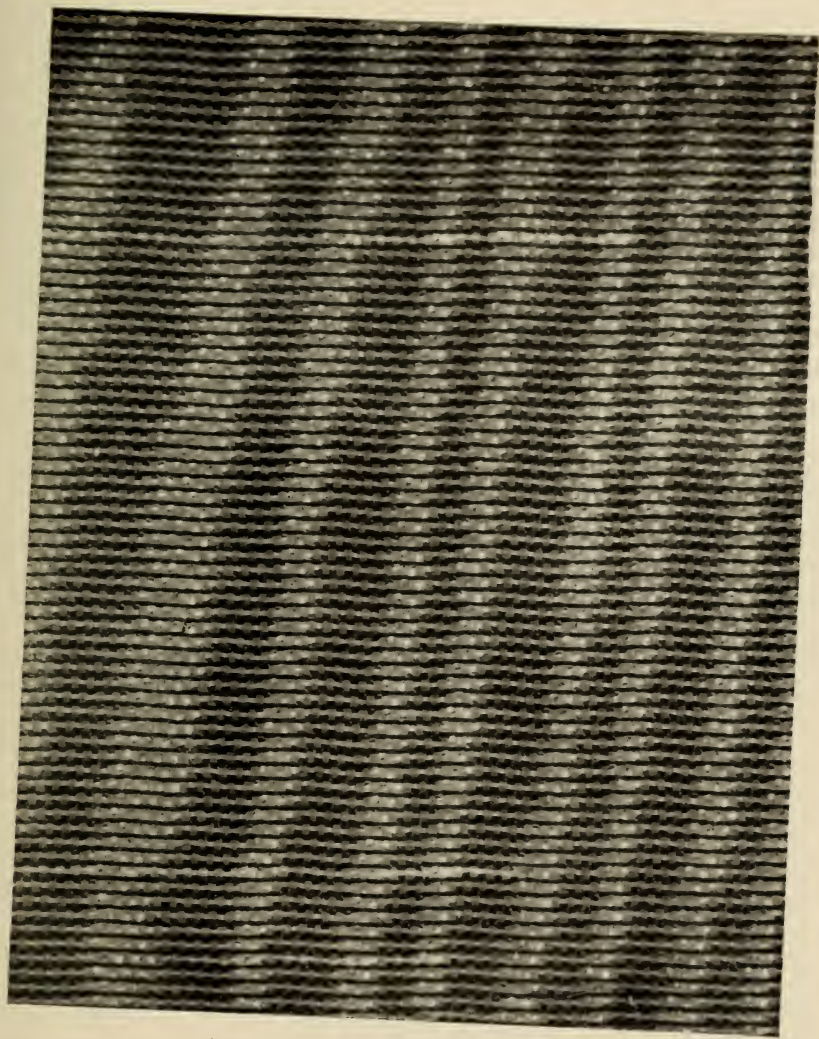
FIG. 56. Filling chafed by shuttle.

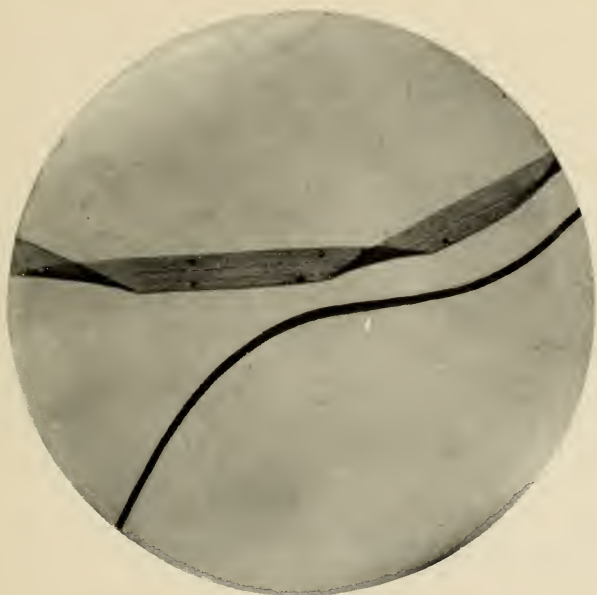
FIG. 62a. Abnormal flat filament and normal round filament.

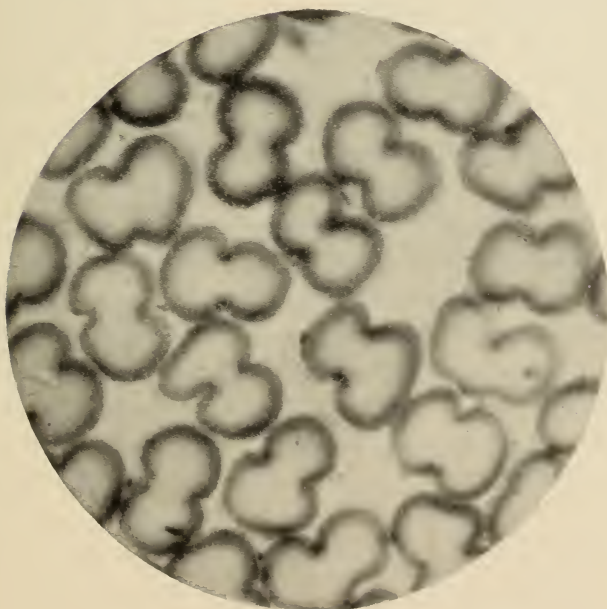
FIG. 63b. Cross section of defective end.

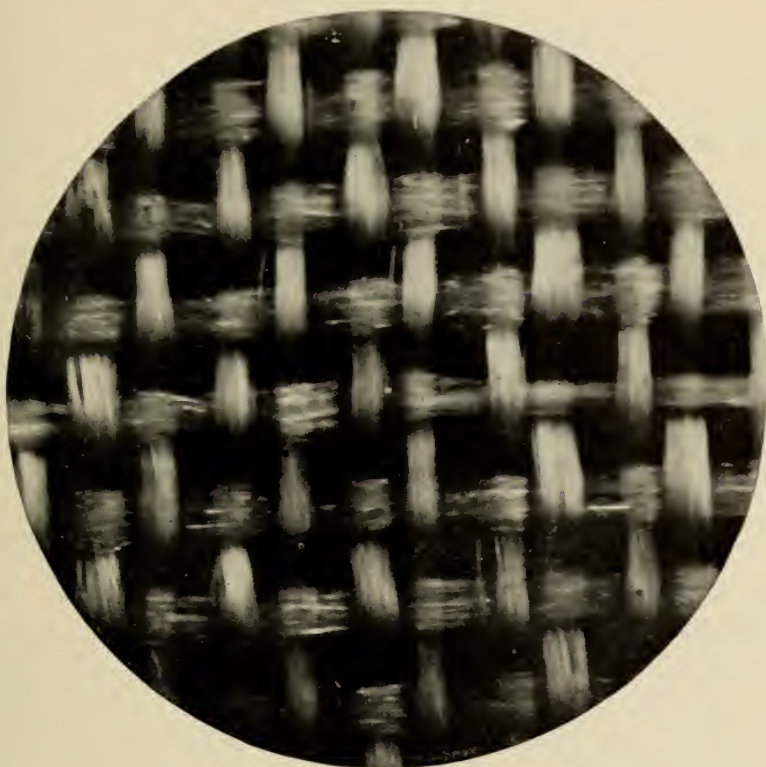
FIG. 65a. Streak due to adhering filaments.

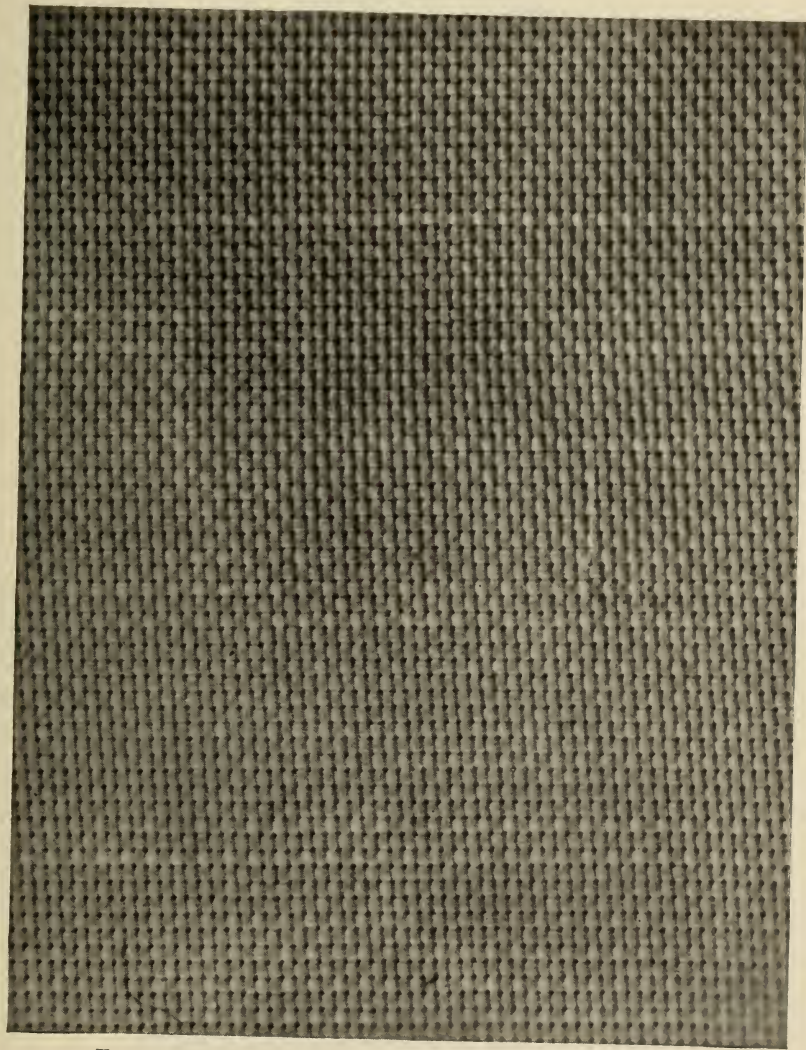
FIG. 67. Streaks due to unremoved finish on filling yarn.

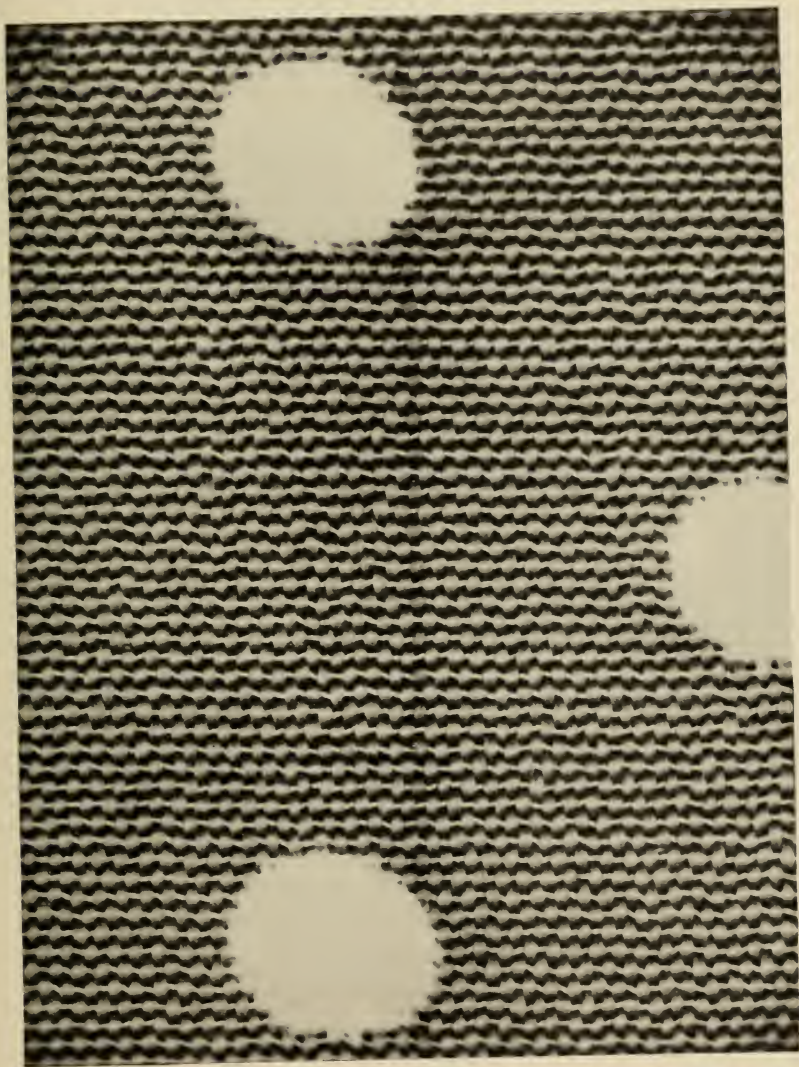
FIG. 69. Dark end due to mixed rayon.

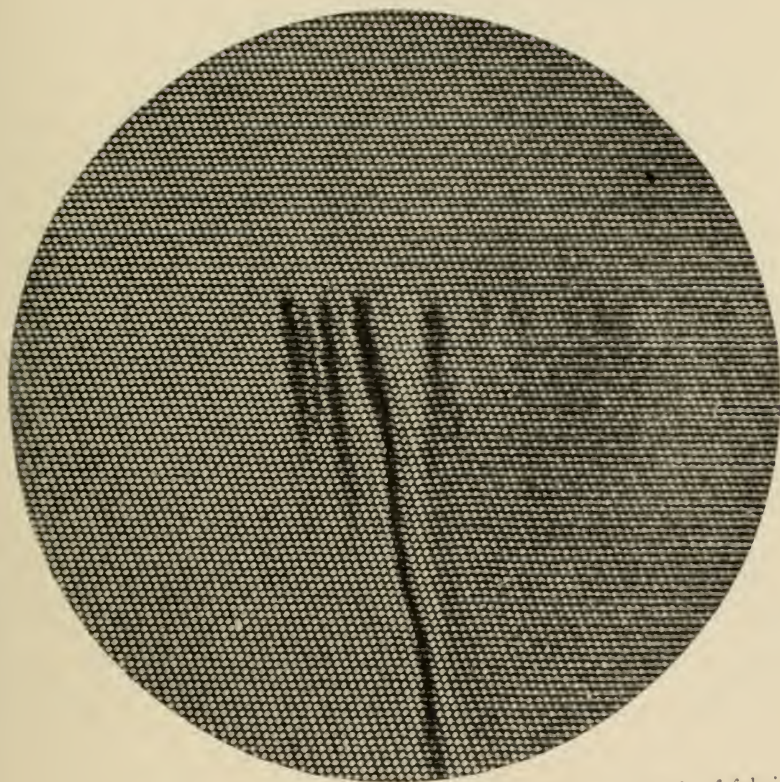
FIG. 70. Creases due to variation in filling-yarn shrinkage (back of fabric).

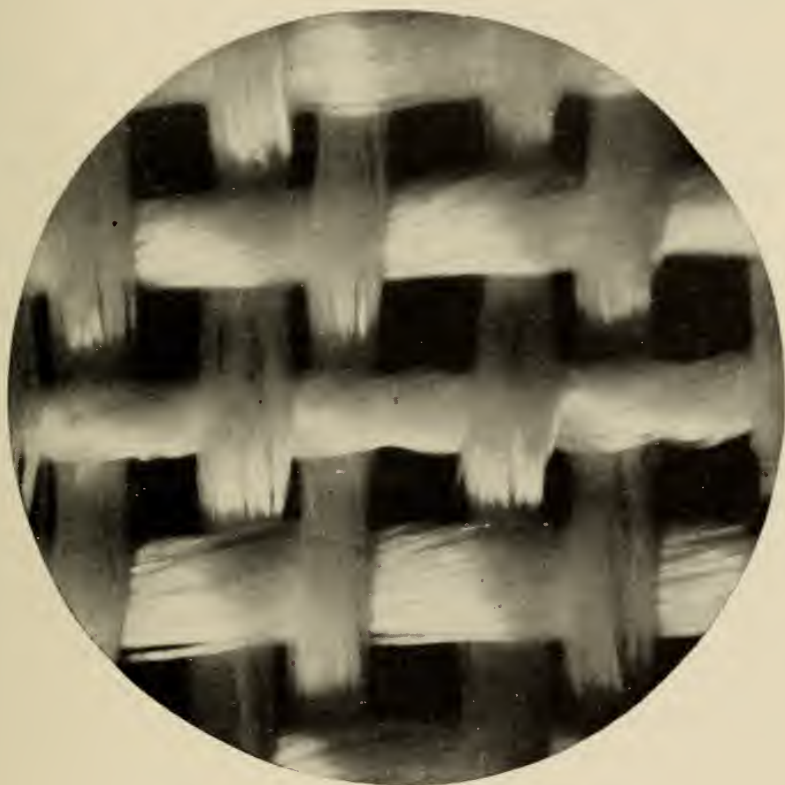
FIG. 71. Abnormally high filling-yarn twist.

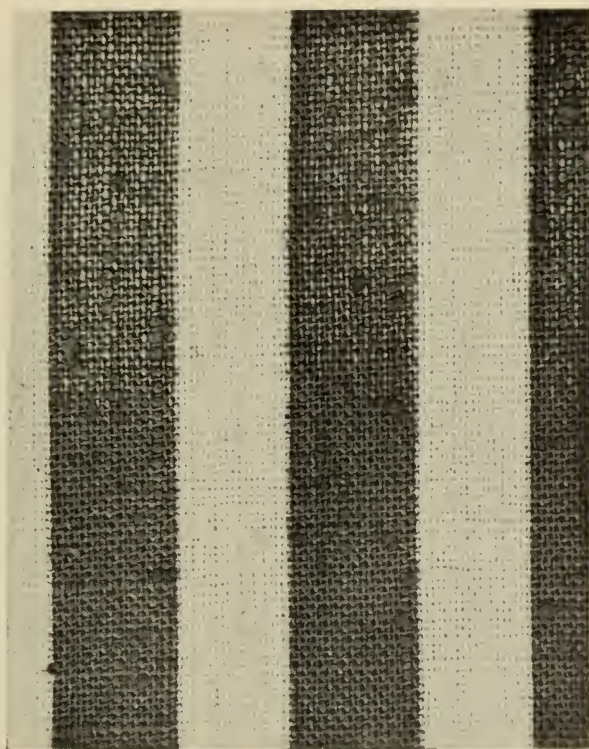
FIG. 74a. White discharge paste carried over to blue-dyed ground stripe.

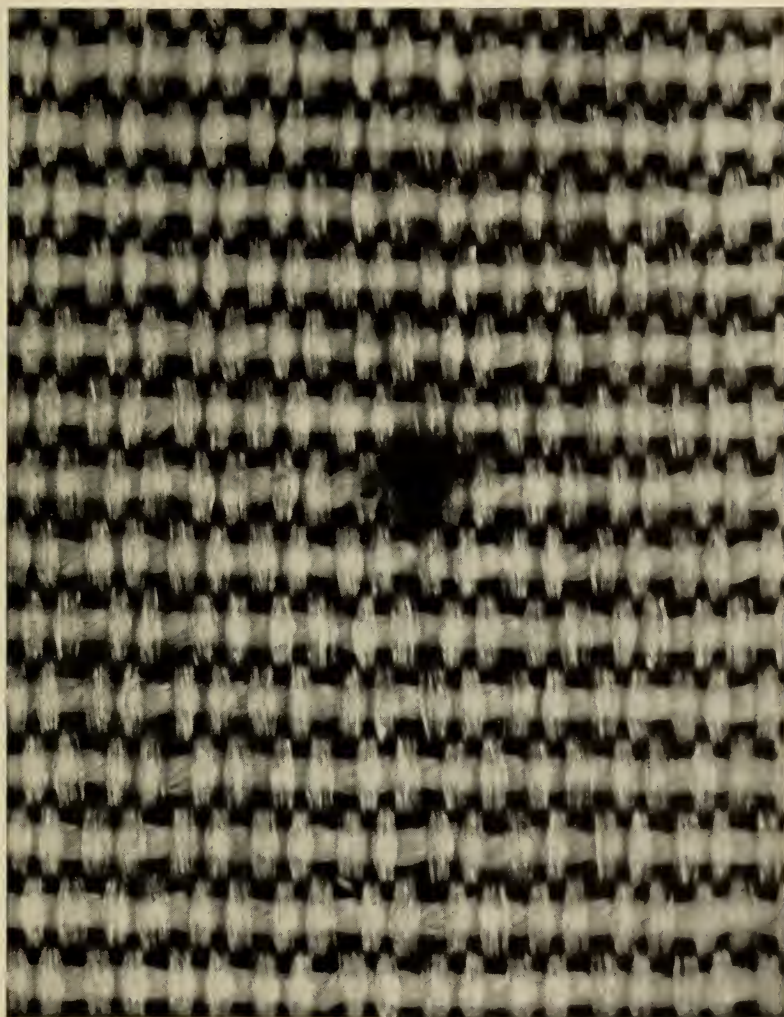
FIG. 75. Dyestuff deposit on fabric.

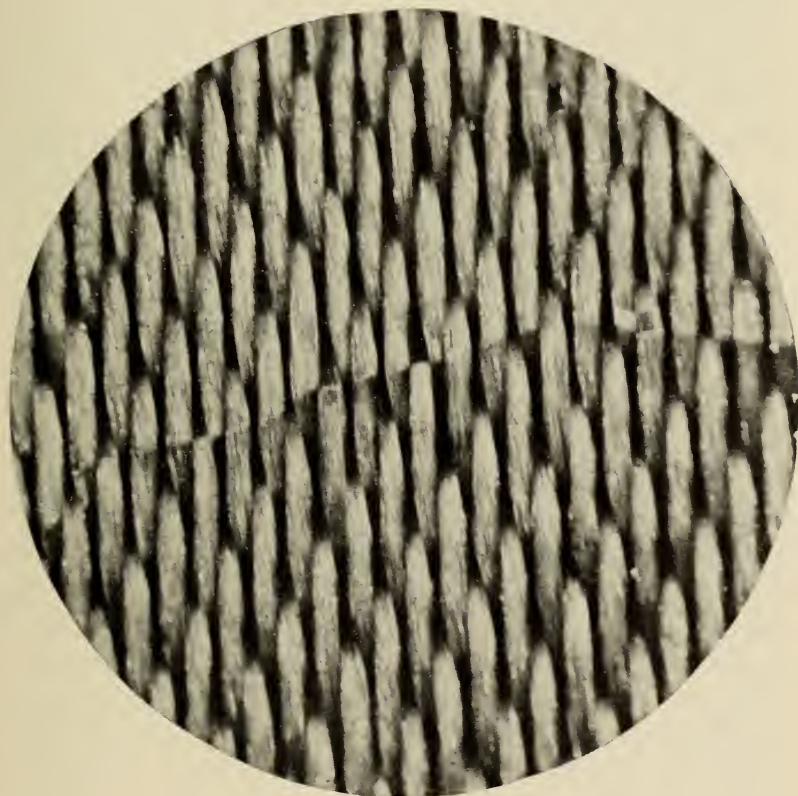
FIG. 77. Fabric distortion from calender imprint.

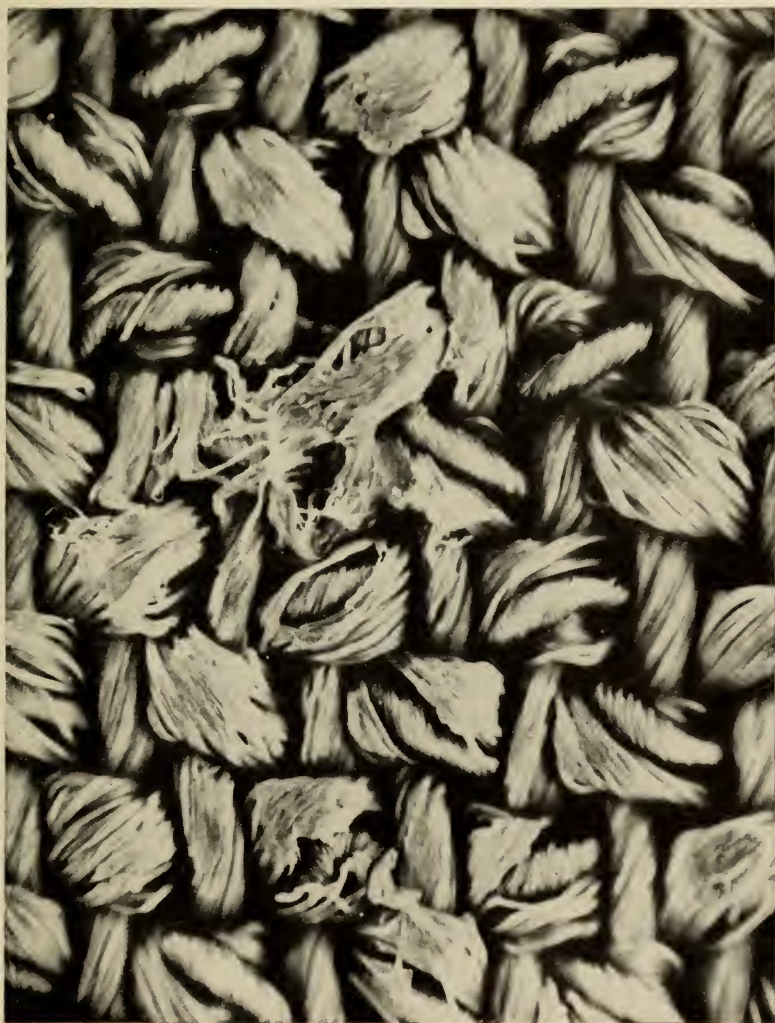
FIG. 78. Stains due to partial dissolving of acetate yarns.

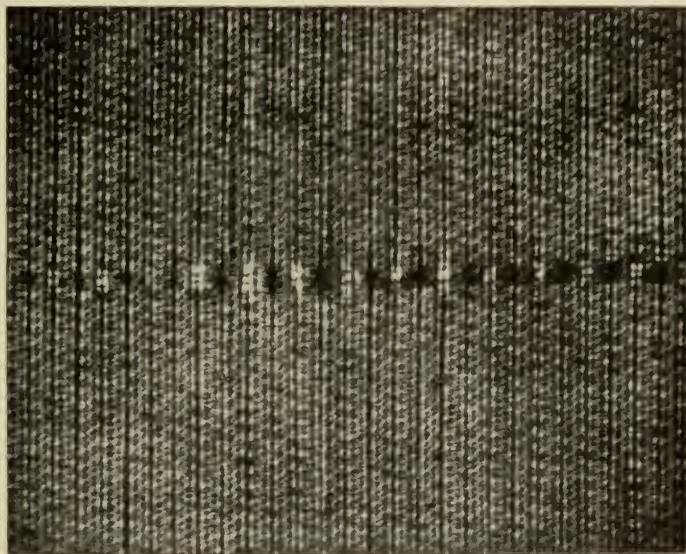
FIG. 81a. Streak viewed by transmitted light.
